The following article outlines my attempts to fix some issues with my Nexstar 8 GPS slewing roughly.

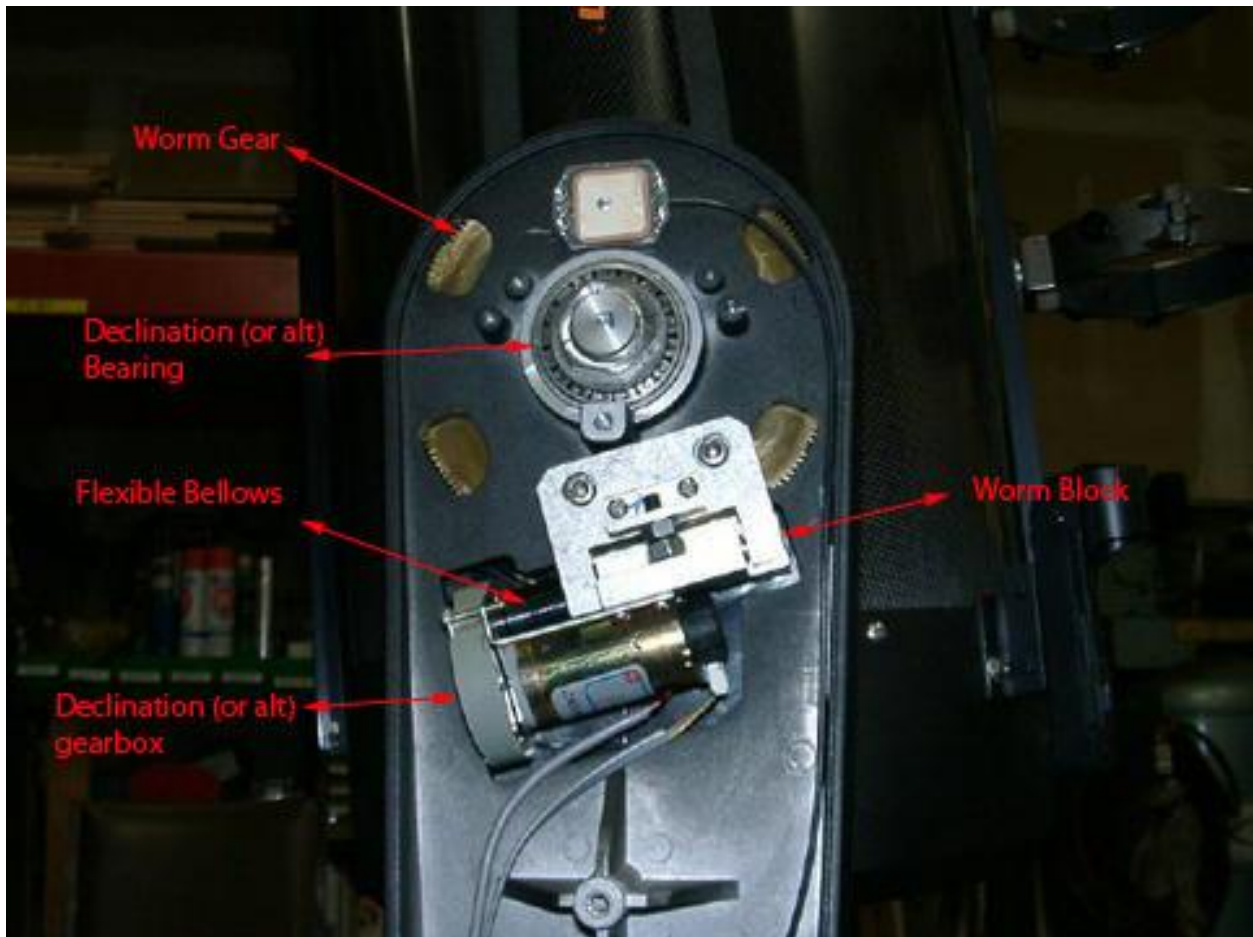
After a surprisingly simple disassembly process, I was looking at the declination bearing, and I couldn't remove the bearing at all. Perhaps there is a difference between the Nexstar 8 GPS and the Nexstar 11 declination assembly, but I couldn't get that thing to come out no matter what I tried.

I went down the path of trying to get at the Declination clutch first. Somebody pointed me to Matthias Bopp's very helpful article on disassembling a Nexstar 11 GPS to replace the declination (or alt) clutch here: http://www.dd1us.de/Downloads/replace%20or%20adjust%20altitude%20clutch%201_3.pdf Using this as I guide, I started to work.

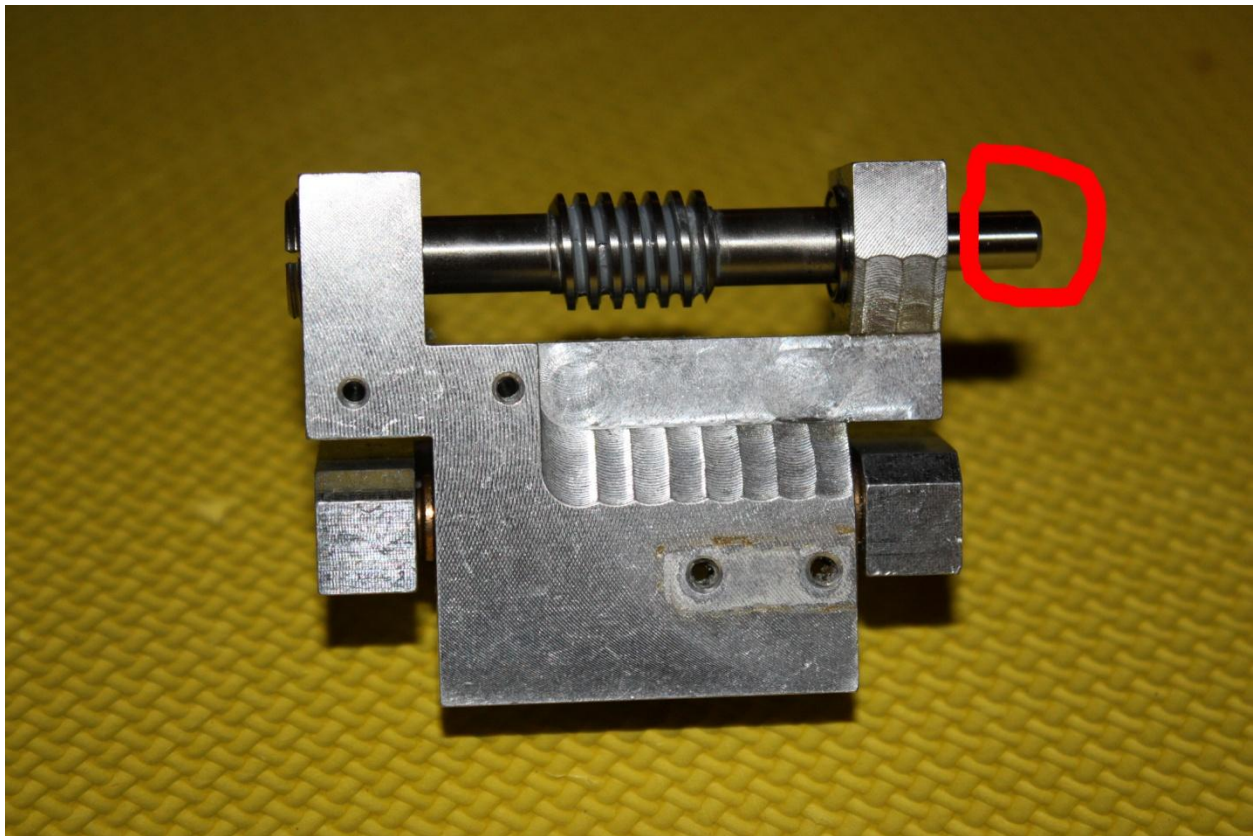
At the suggestion of somebody on Yahoo group, I bought a mechanic's stethoscope to try and narrow down where the roughness was coming from. I checked the motor, the gearbox, and the brass worm gear. None of them seemed to be where the roughness was coming from. I removed the motor from the worm block so that I could see if any the gears in the gearbox were visibly damaged. I couldn't see anything obvious, but the worm itself seemed very difficult to turn by hand from the circled portion in the following picture, which is where the flexible bellows from the gear box attaches:

I gave the worm bearings a spray with WD 40, but it didn't seem to make much difference. It was, however, the first thing I found that didn't seem to be working as it should. Unfortunately, the need to work for a living put an end to my efforts for the day.

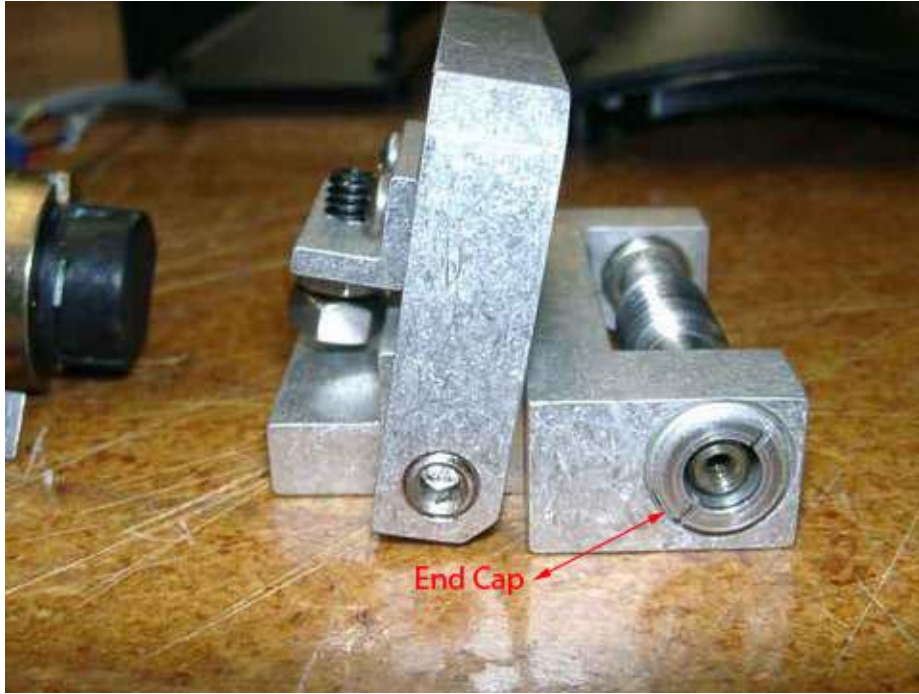
I picked where I left off on Day 5, with the idea the worm should be rotating smoothly, I went about trying to get at the bearing to see if they were worn, dirty or damaged. As I started loosening the end cap, shown here:

the rotation of the worm suddenly became silky smooth. I removed the end cap anyways and got the worm and bearings out. Here are the pieces of the worm block assembly:

My working theory is that when the DSI/barlow combination hit the base, some of the torque from the declination motor ended up getting transferred into the end cap, tightening it to the point where the worm rotation was no longer smooth. I have no idea if this is actually what happened, but would explain the problem.
